MICHIGAN FORESTRY BEST MANAGEMENT PRACTICES

2016 MONITORING STUDY RESULTS

REGION 2 (EASTERN UPPER PENINSULA)

REGION 3 (LOWER PENINSULA)

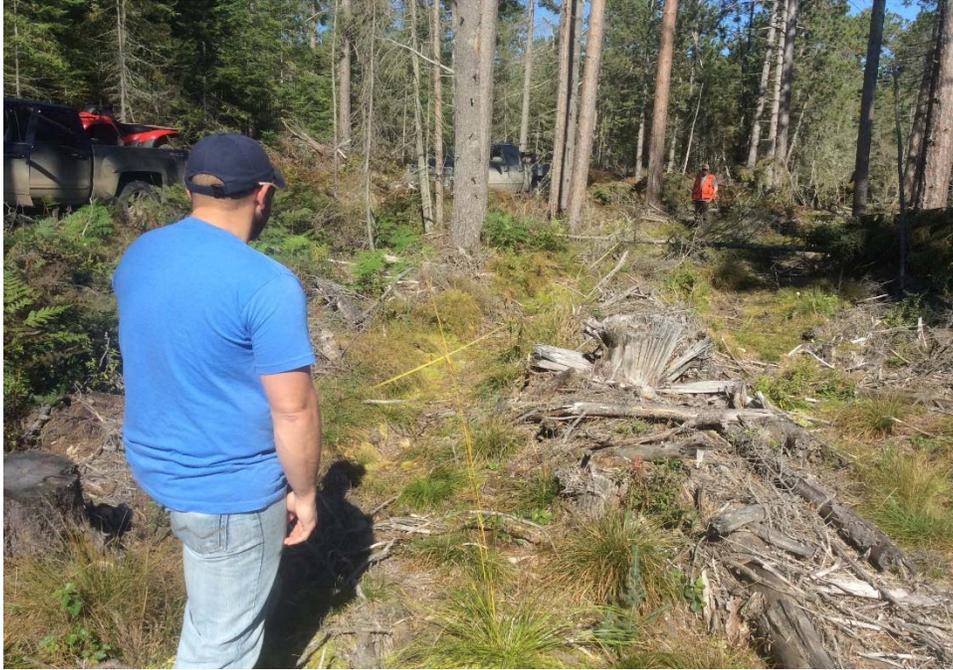
Foresters taking measurements to determine if a rut is present in a wetland.

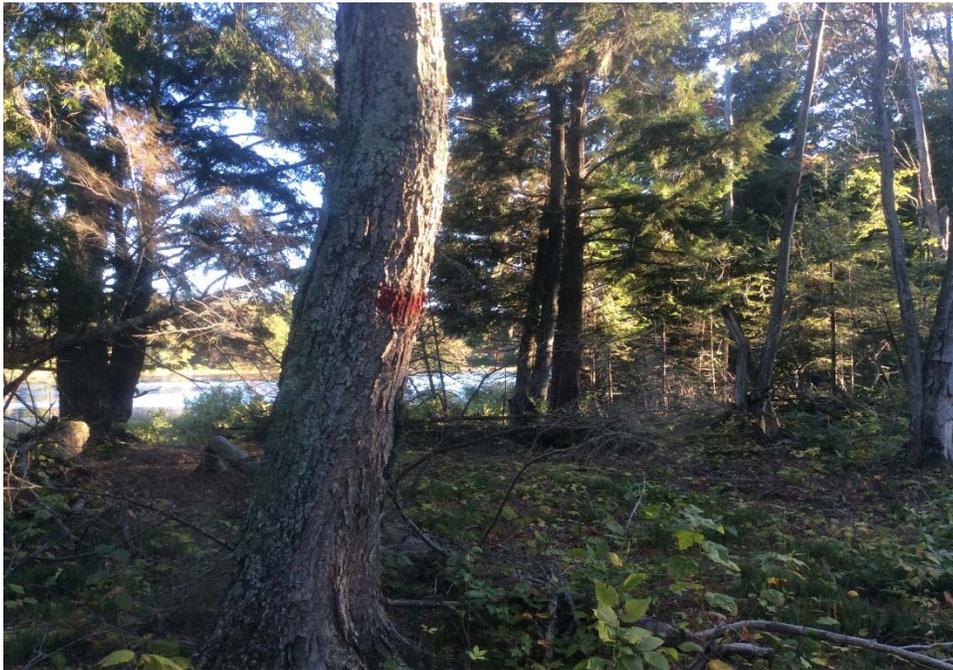
The red paint on the tree above marks a buffer protecting a lake from a timber harvest.

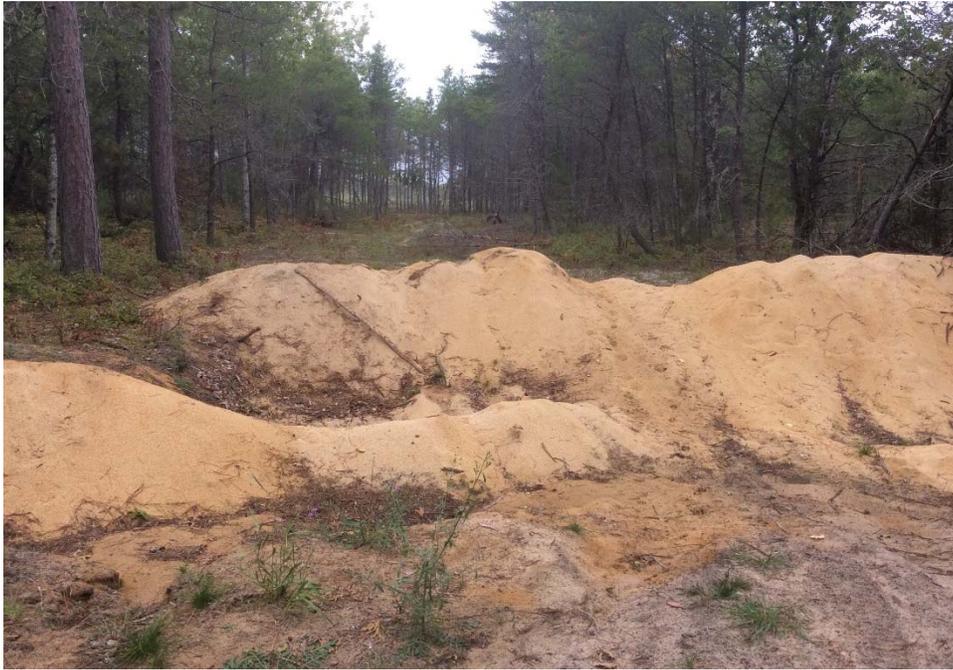
This forest road was bermed following harvest to prevent vehicle entrance to the timber sale area.

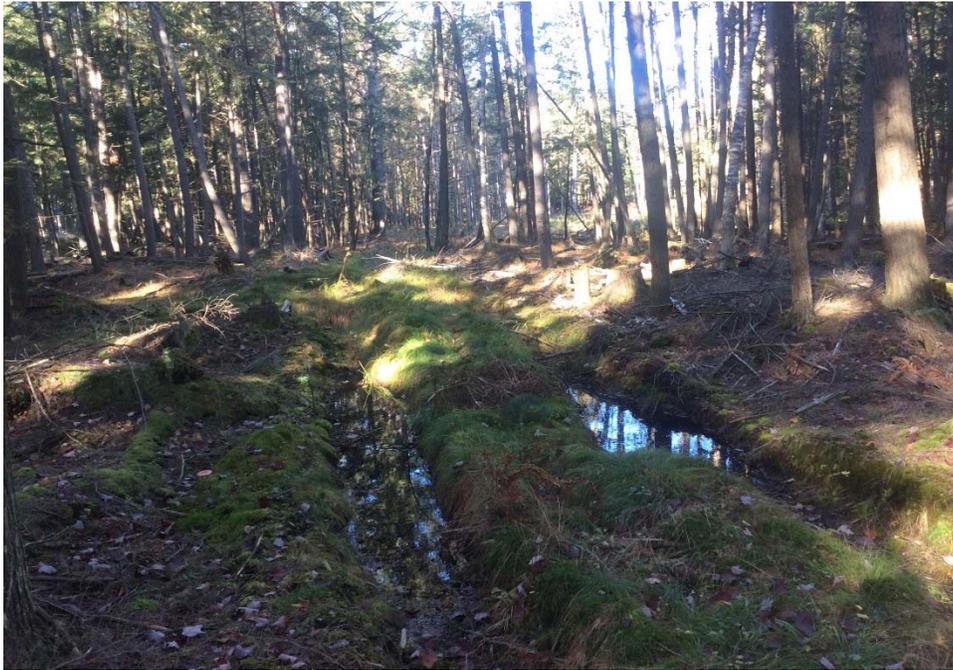
Another question that received a negative rating greater than 10 percent of the time is "Wetlands: Excessive rutting avoided: > 6 inches deep and 25 feet long" (this occurred in all three regions). This is most likely caused by the difficulty in minimizing soil disturbance when harvesting in wetland environments and by the limited sites with wetland harvesting. Region 3 had several questions pertaining to stream crossings, but all negative ratings came from one site with a poor crossing. Region 3 also had several negative ratings regarding the protection of threatened and endangered species and archeological sites. These rating were determined from discussion with a landowner who was present during the site visit and acknowledged that no check was made (Tables 14 and 15).

Ruts occurring in a forested wetland are shown above.

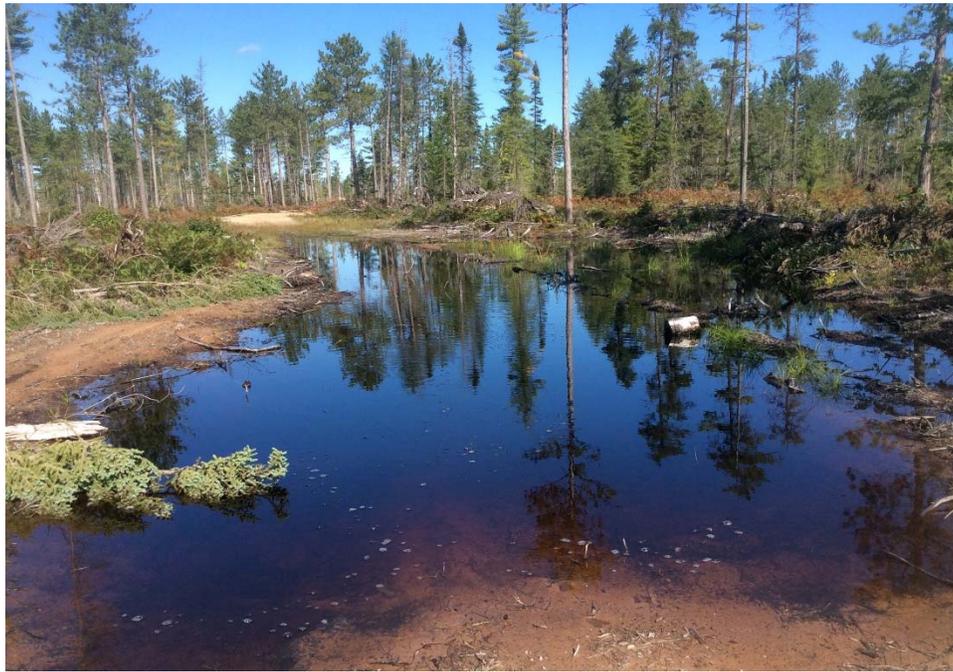
The above photo shows standing water in a landing area used to deck forest products during an active timber harvest.

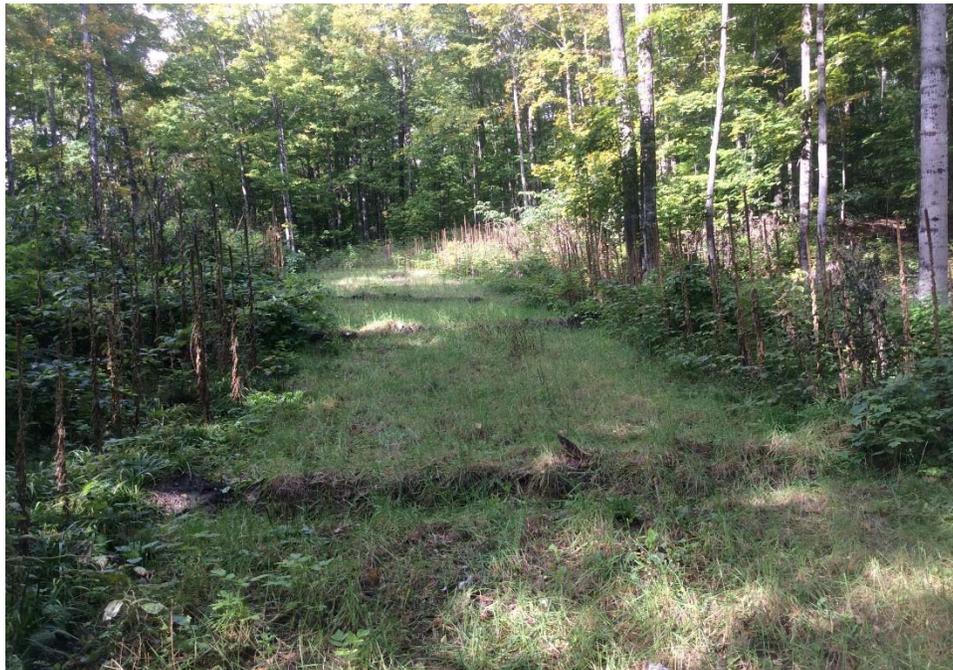
This photo demonstrates a properly stabilized forest road. Water bars and road seeding were two effectively utilized BMPs.

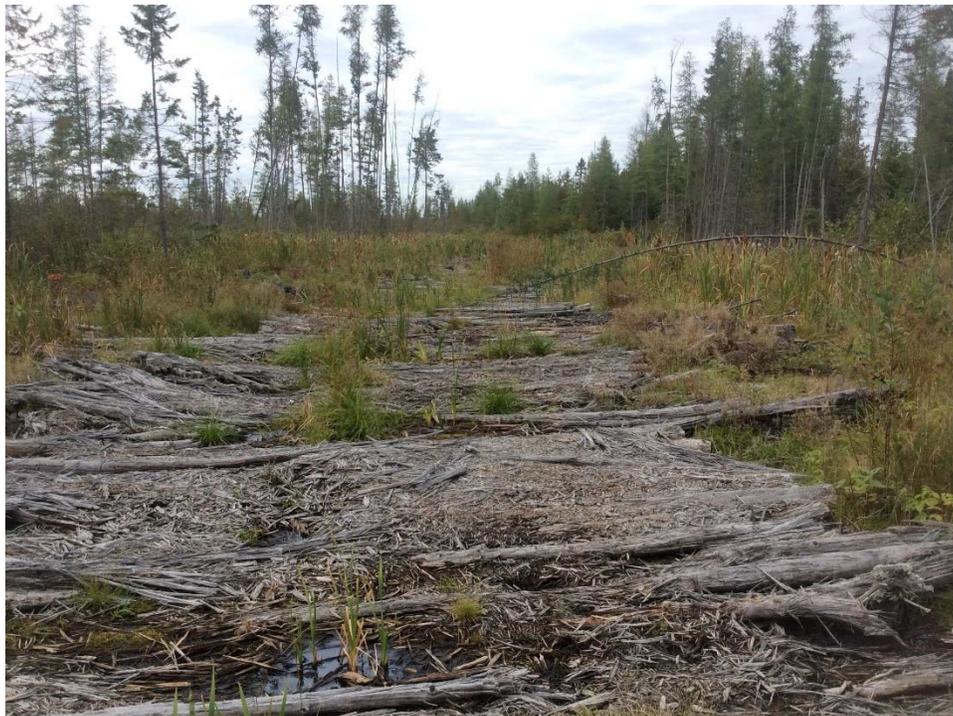
Slash used to prevent rutting in a wetland above has not been removed from the site, but did successfully prevent rutting in the sensitive area.

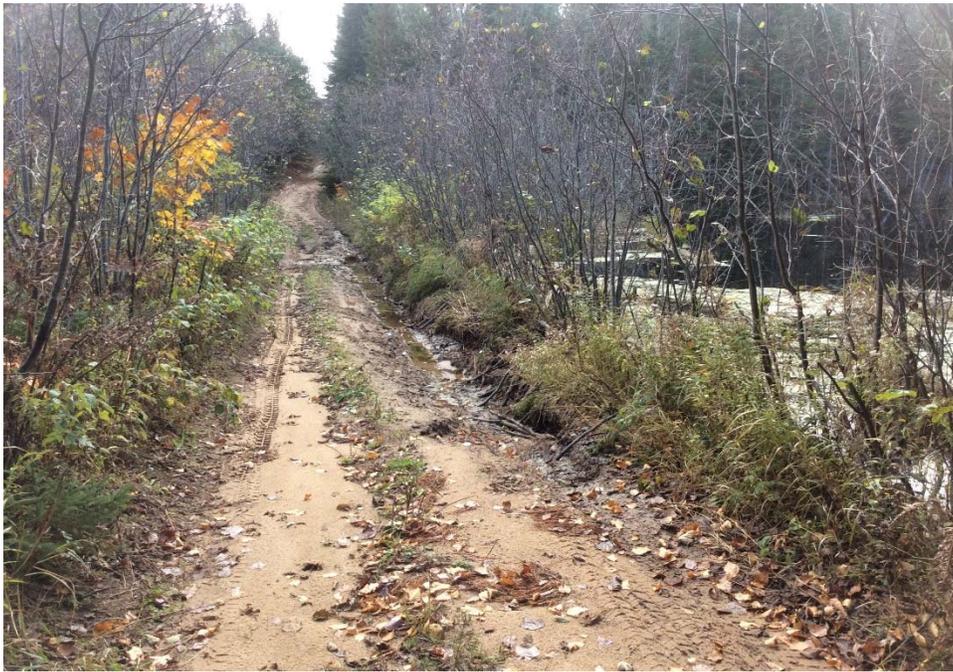
A forest road with erosion near a beaver pond.

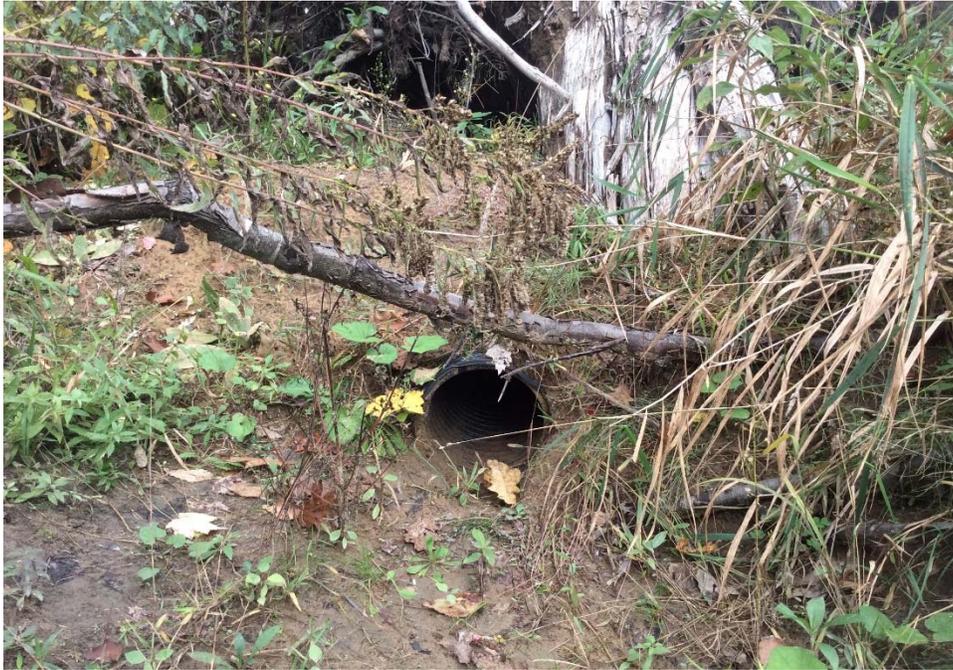
A properly installed cross drain culvert.
